## Practical procedure for the assessment of the stability and probability of failure of cut slopes in the urban area of Tijuana, Mexico

PhD. Aldo Onel Oliva-González<sup>1</sup>, Ing. Marco Antonio Berumen-Rodríguez<sup>2</sup>, Ing. David Mascareño-Jiménez<sup>3</sup>

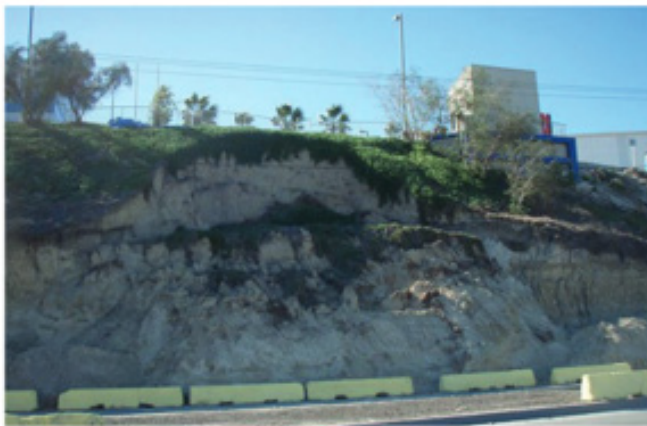
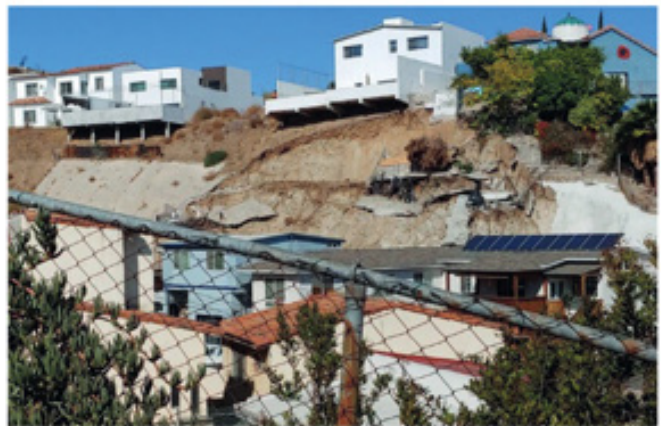
**Figure 1.** Sites affected by slope failures in the urban area of Tijuana.

Over the past three years, shear slope failures have been reported in five urban neighborhoods, resulting in severe damage to at least 25 homes and putting nearby structures and infrastructure at risk (see Figure 1).

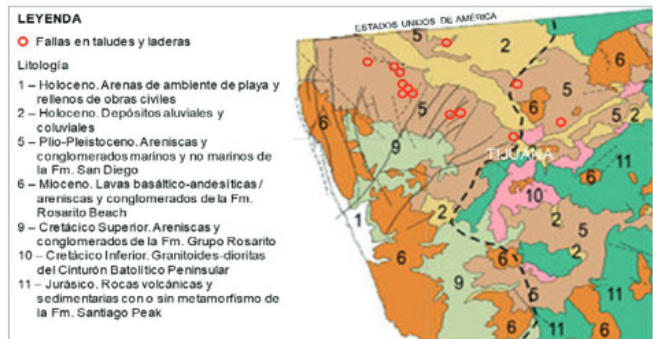
**Figure 3.** Slope and hillside failures recorded in the urban area of Tijuana (between 2010 and 2020).

Based on geological-geotechnical studies and historical records of geotechnical instability phenomena, areas susceptible to slope failures were identified (see Figure 3).

Most of the failures have occurred in lithologic unit 5, characterized by marine and non-marine sandstones and conglomerates of the San Diego Formation [16]. In their natural state, these formations consist of silty and clayey sands with gravels and boleos.

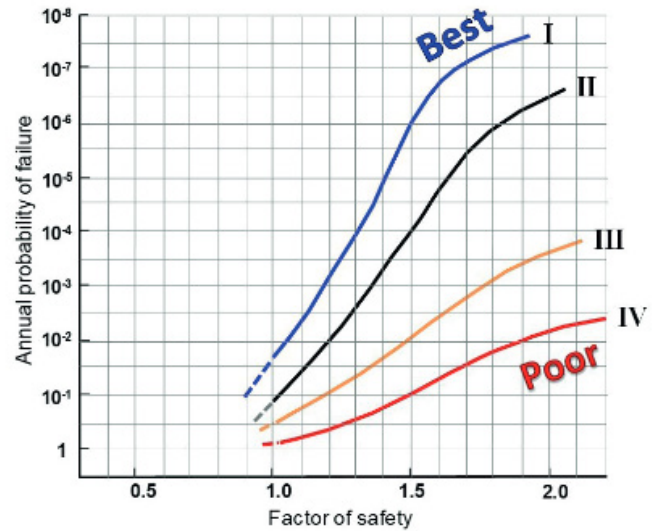
**Figure 5.** Annual probability of failure vs. safety factor. Source: [26].

**2.3.2 Probability of failure vs factor of safety.** The correlation between the annual probability of failure and the safety factor developed by Silva (2008) [26] is proposed for use. This correlation is considered adequate as it complies with the fundamental considerations of probability theory and makes good practical sense (see Figure 5).

The curves in Figure 5 represent four categories of projects based on the level of engineering, ranging from the best (category I) to the worst (category IV) [26].

- Category I: facilities designed, constructed, and operated with state-of-the-art engineering and complying with current standards and technical specifications.
- Category II: facilities designed, constructed, and operated using standard engineering practices.
- Category III: facilities that did not have design and are poorly constructed or operated.
- Category IV: facilities with little or no engineering.

- Categorize the projects and facilities where the slopes under analysis are located. Prioritize geotechnical aspects during the study, design, and construction phases for the slopes, structures, and infrastructures in their immediate vicinity.
- Determine the factor of safety of the slopes, using Tables 2 and 3, or Figures 6(a) and 6(b).
- Estimate the annual probability of slope failure from the factors of safety and project categories using Figure 5.

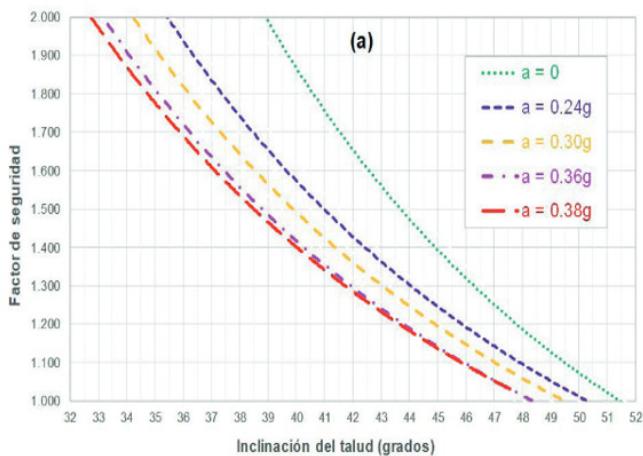
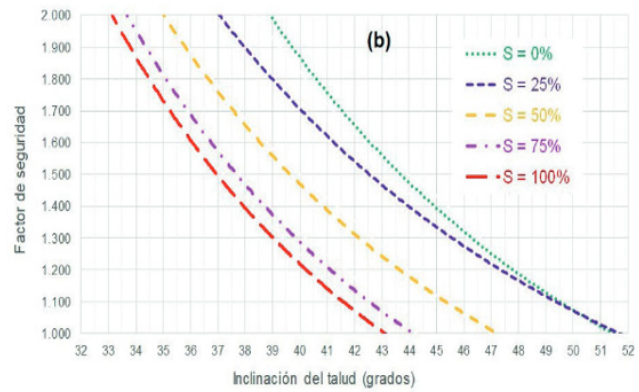
**Figure 6.** Minimum factors of safety vs slope inclination. (a) For different seismic accelerations; (b) for different ground saturations.

Figures 6(a) and 6(b) show the abacuses of minimum factors of safety performance for different accelerations and soil saturation levels, respectively.

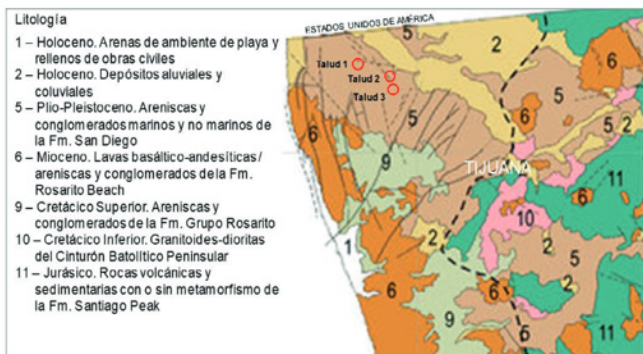
**Figure 8.** Location of slopes analyzed on the geologic map of Tijuana.

To test the feasibility and practicability of the procedure, three slopes in the urban area where failures occurred between December 2019 and July 2020 were analyzed (Figure 8).
